## Repair of 250 SL Multifunction Switch

Hello everybody below is a short description of a method for disassembling the turn signal switch also known as the combination switch and restoring its functions.

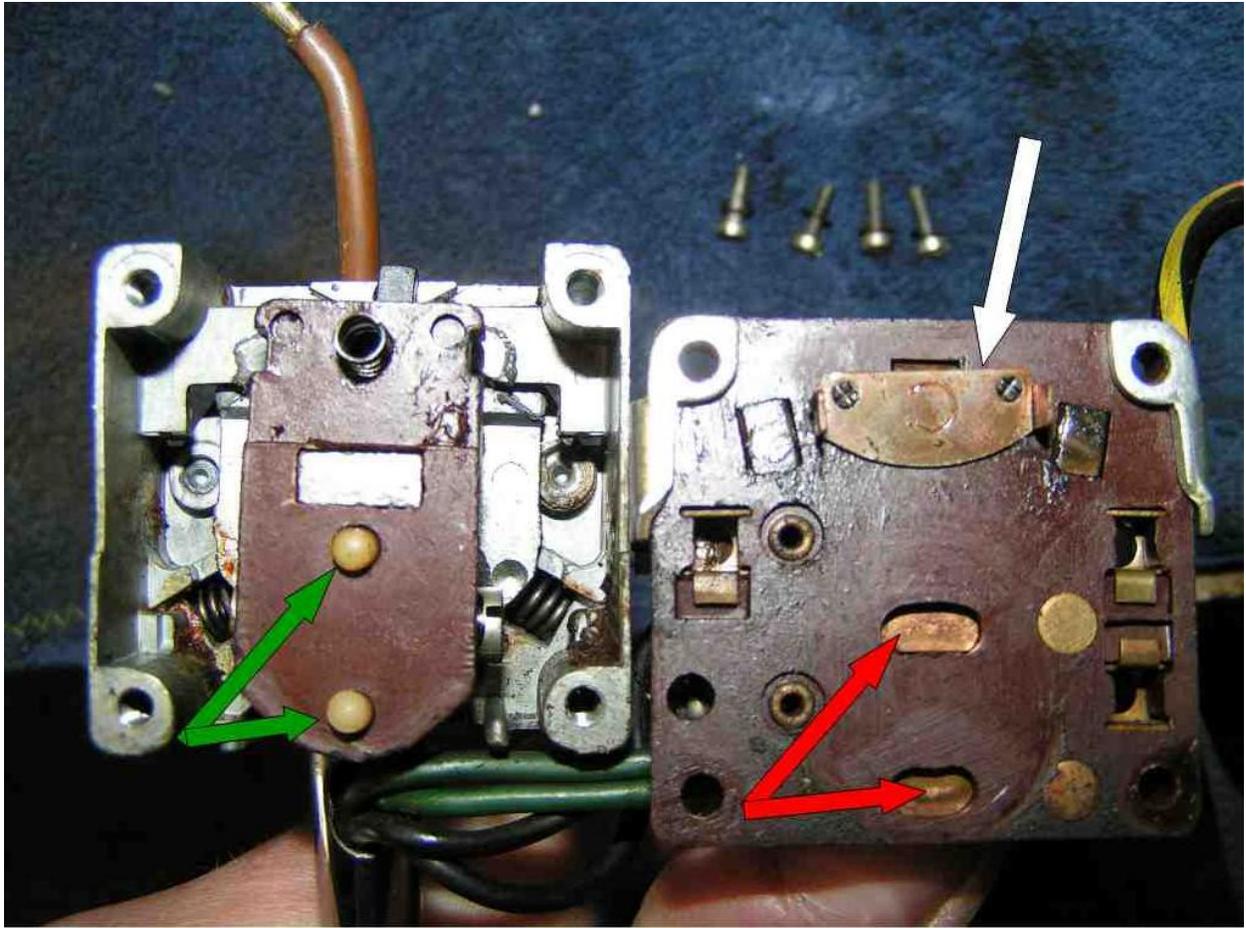
After loosening and removing the 4 screws, the Bakelite lid can be lifted off. The contact for the turn signal function is visible (or meets [or opposite to]). A spring pushes against the contact from the back. It is important to note that in the reassembly that they contact again with the flat side facing up (see white arrow). Furthermore, you can see the "switch" for the turn signal and washer (green arrows). Press this when the lever is pressed against the contacts (red arrows).

Sometimes the windshield washer or LH no longer works. This may be because the contacts are worn out. In my opinion the contacts cannot be repaired, but the "switch" made of plastic can be easily replicated on a lathe. Just reinstall [fit, incorporate] a little longer to put pressure on the contact again. [Make them a little longer.]

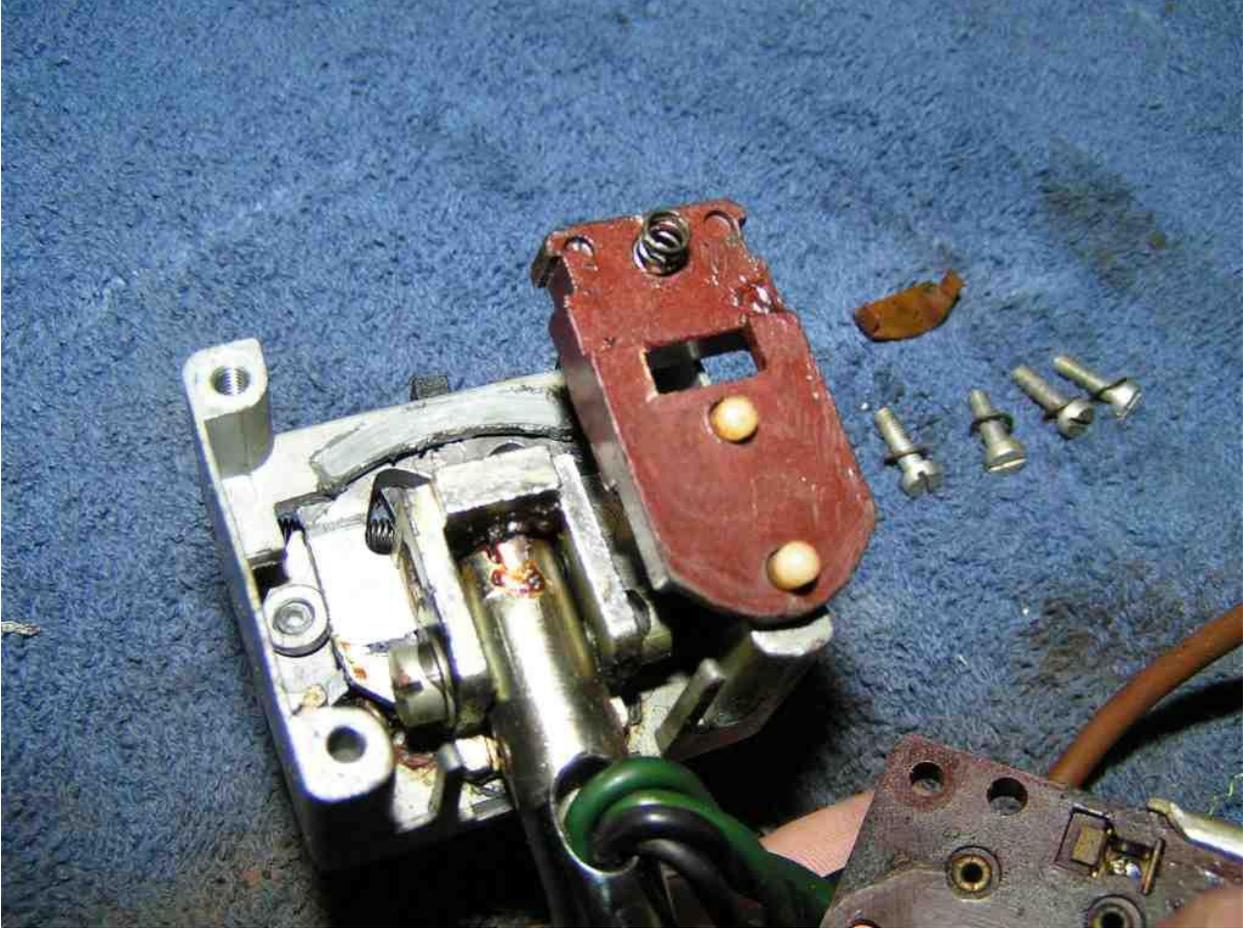
The Bakelite part with the "switches" can now be removed and the individual parts can be cleaned or [i.B.a.] the "switches" are reproduced [remade].

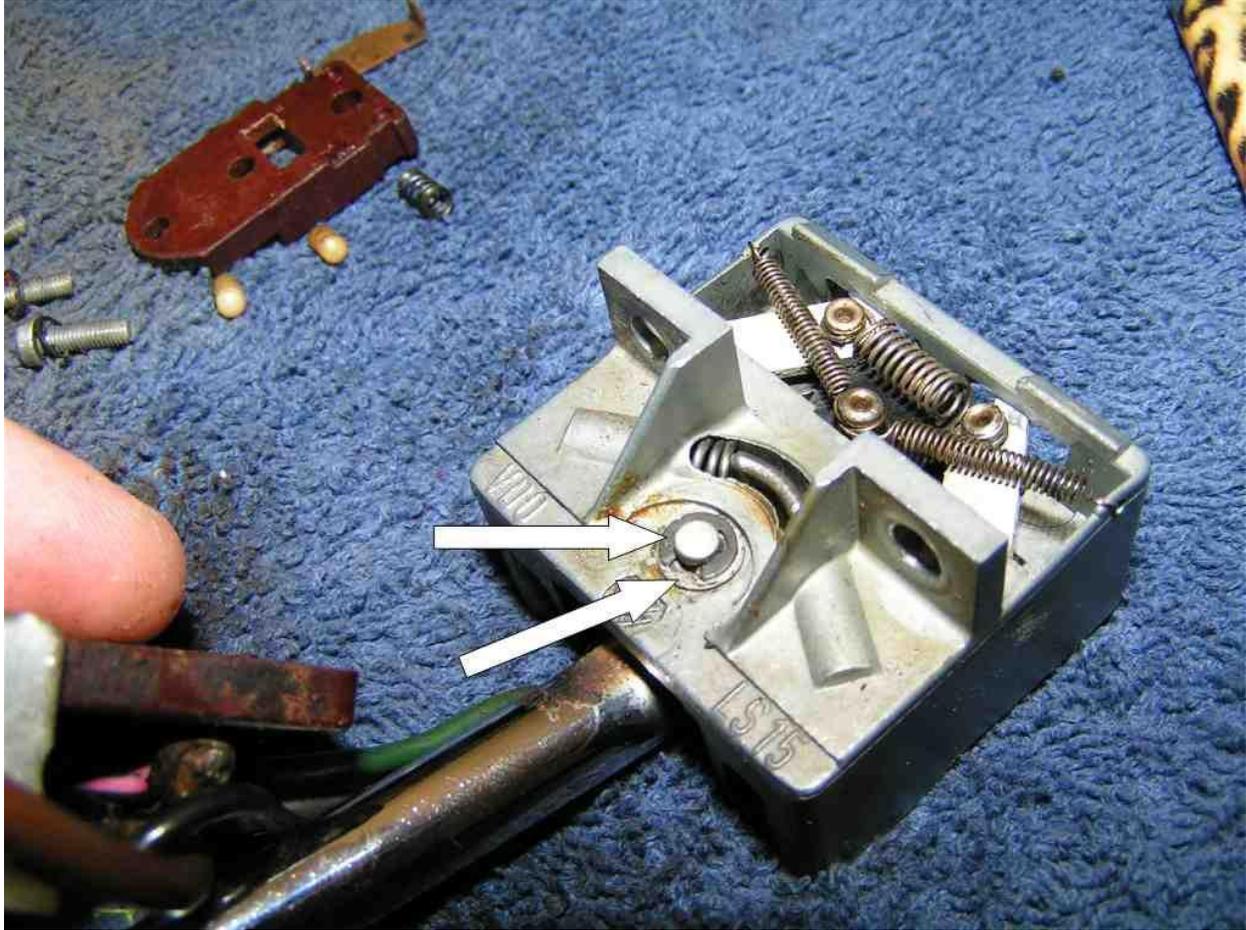
Now you can remove the lever. Release the snap ring and remove the washer (Arrows)

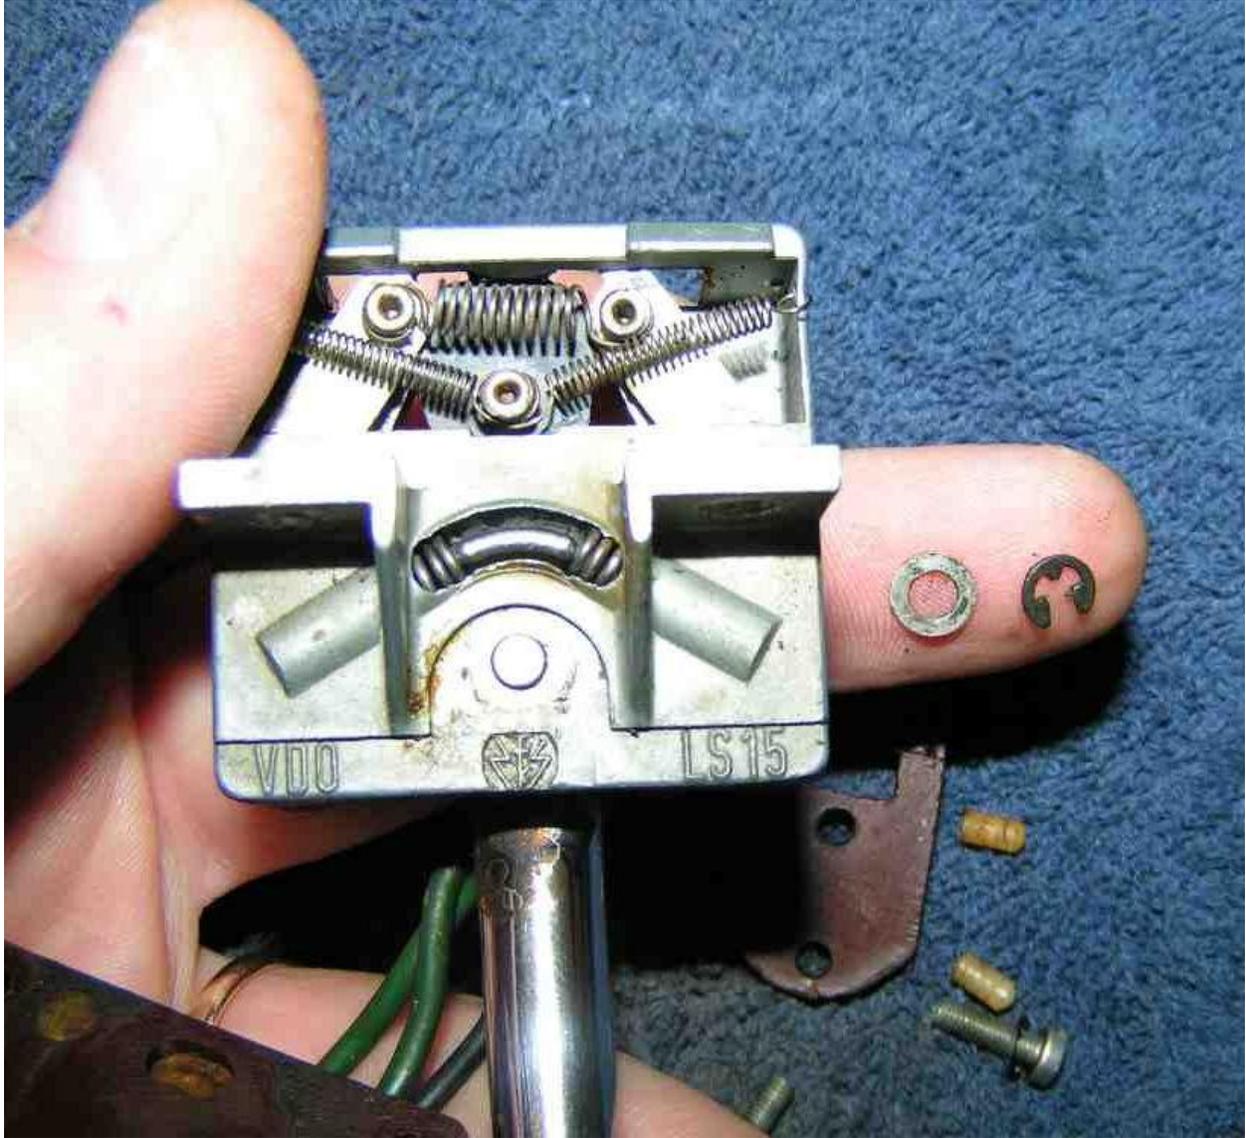
Now take the casting in hand and push the arm forward with "gentle force". This jams a bit because some of the lever is caught between the springs visible in the photo (making the lever spring back). The springs are expected to meet one another - but it's no problem.

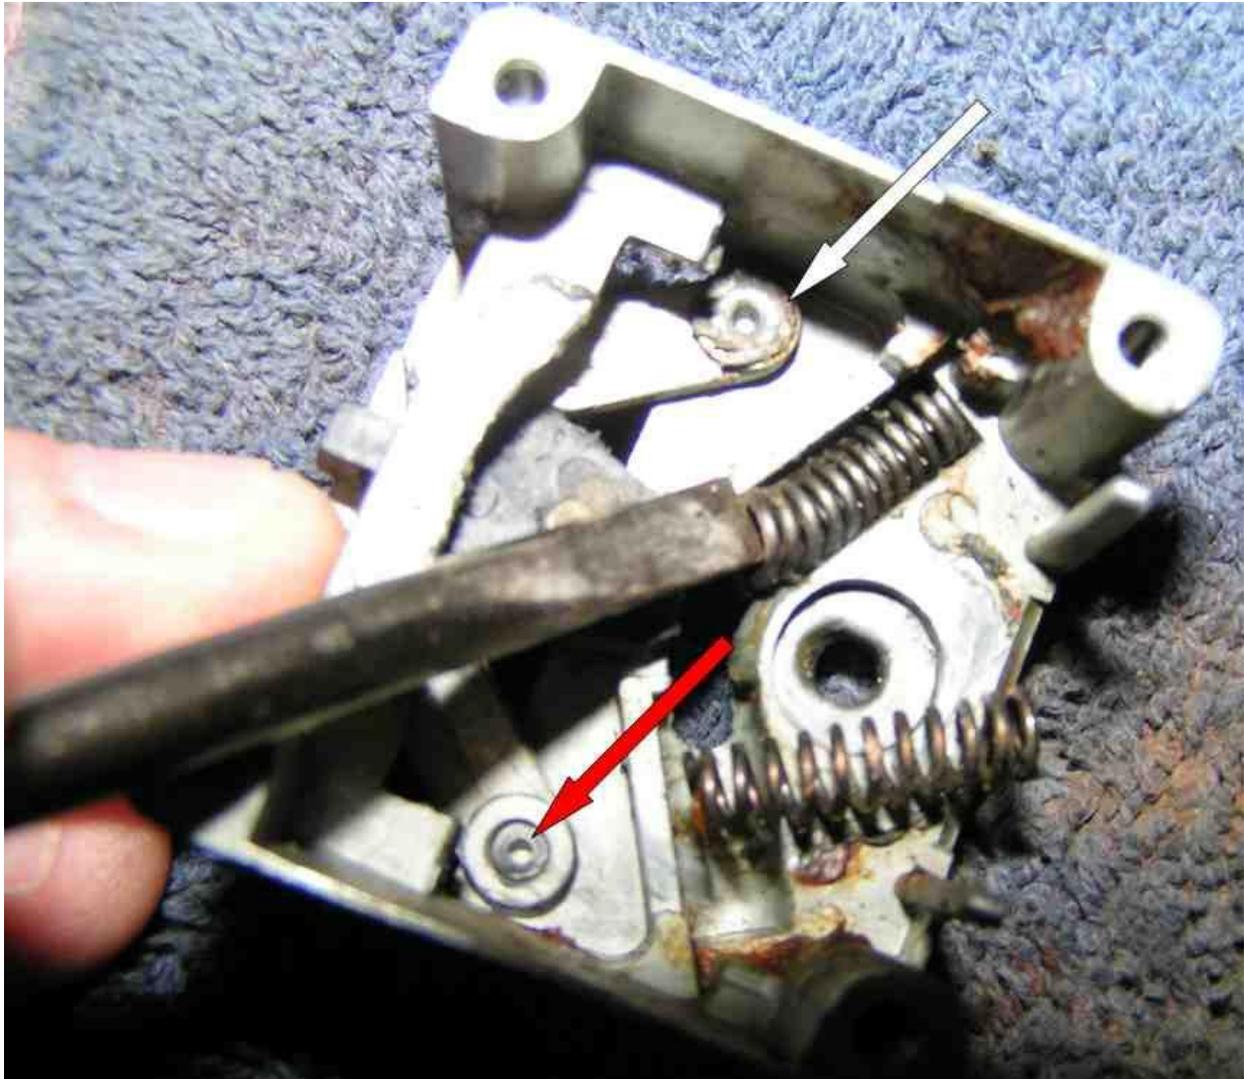
When installing, you can easily replace the above springs with a screwdriver but what you see here is a defect that I find very common. The levers that hold (by means of various springs) the turn signal switch in one position are riveted. Often one or both rivets are broken (white arrow repaired / red arrow broken).

The lever is still on the guide, but has play. If you look at the unassembled switch from above, you can see that the "rollers [parts]" - which sit on the levers, hanging [cocked] a little bit diagonally. I had cases where the function was not impaired, but also cases where filing the part (see instructions below) could not compensate for the error. I'm still working on one Idea to fix this bug. *Addendum to this: Thanks to our member Fritz, we have found a solution as described in detail below.*

Thanks to the Fritz from Swabia who described the fix for the problem with the broken lever rivets. Simply drill out the defective rivet completely and drill a M3 thread into the housing cover. Then the lever is attached with a corresponding brass screw - done! Thank you Fritz55mann for the tip!

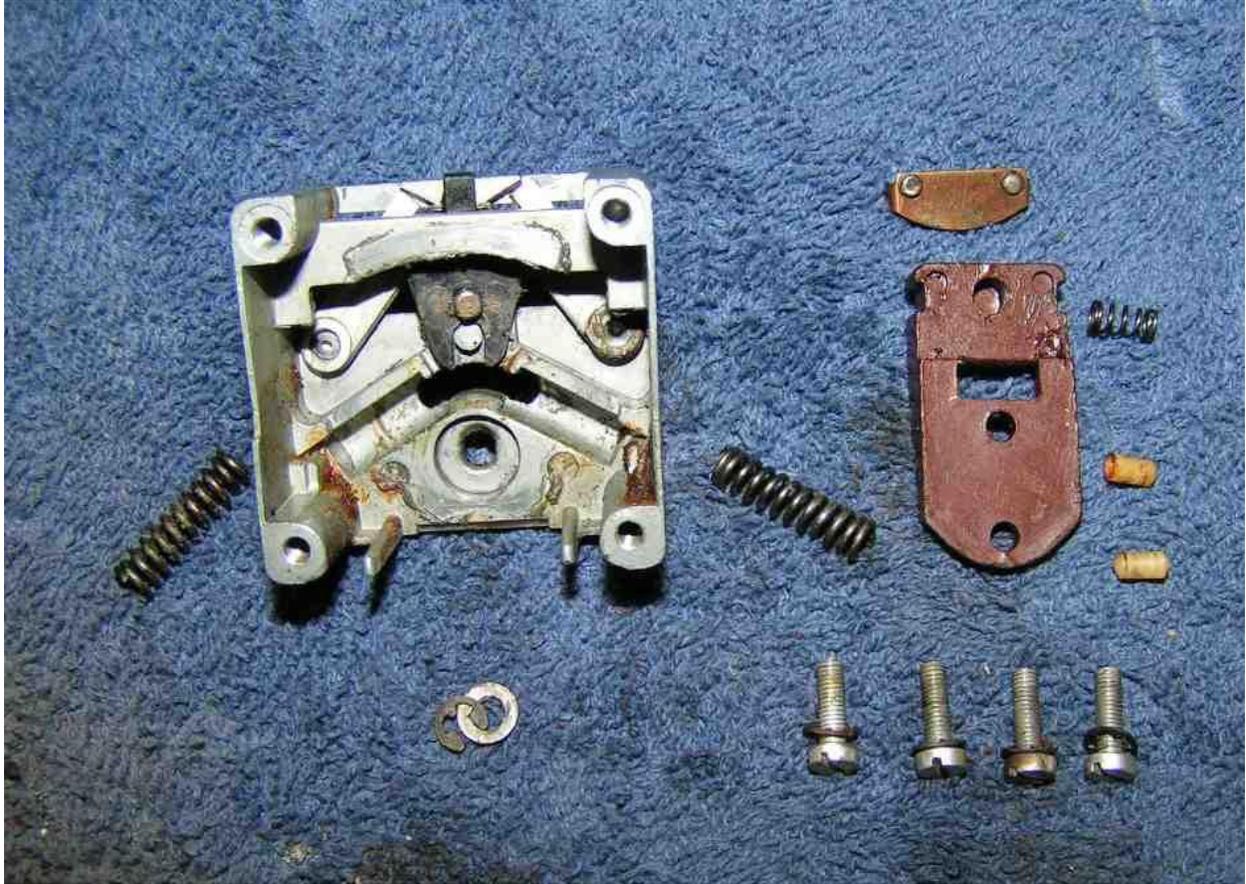
If, when the turn signal or wiper / washer is operated, the switch no longer returns automatically to the middle position [normal position], it may be on a small ridge [burr, edge]. For this - or just to clean the part properly - loosen the 2 screws. The lever can then be separated from the lower part. Careful, do not

lose the ball.

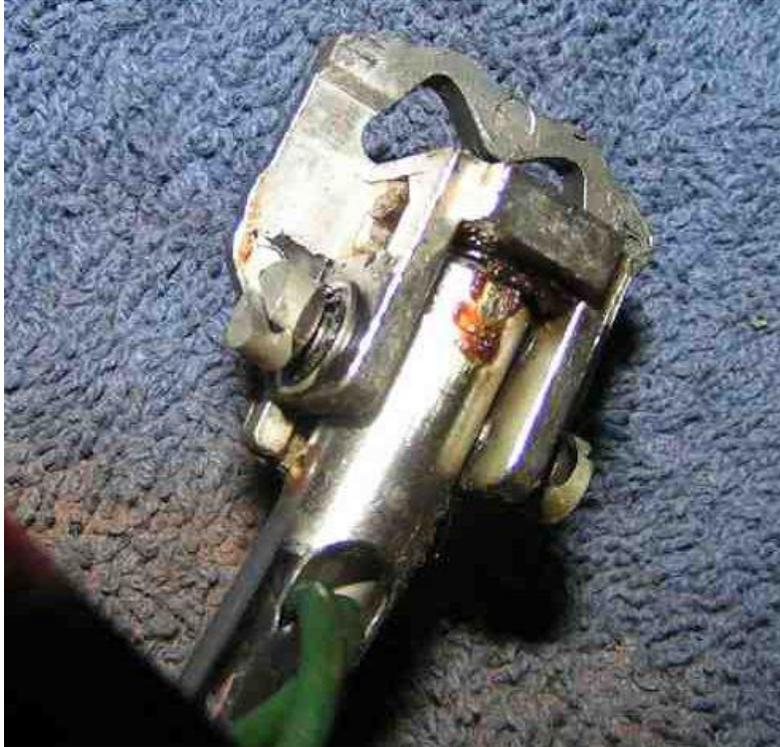
If the turn signal switch no longer locks properly, you can gently re-file at the points shown here. The above-mentioned parts snap in when pressing the turn signal switch here and hold it up or down. If the

edges become worn over the years, the parts slip over them and no longer hold the lever in position. Caution: do not file too much; otherwise the parts will hold so tight that you can no longer move the turn signal by hand. Here a little trial and error is better. It is better to take it apart more than once and re-file - eventually it will work out!

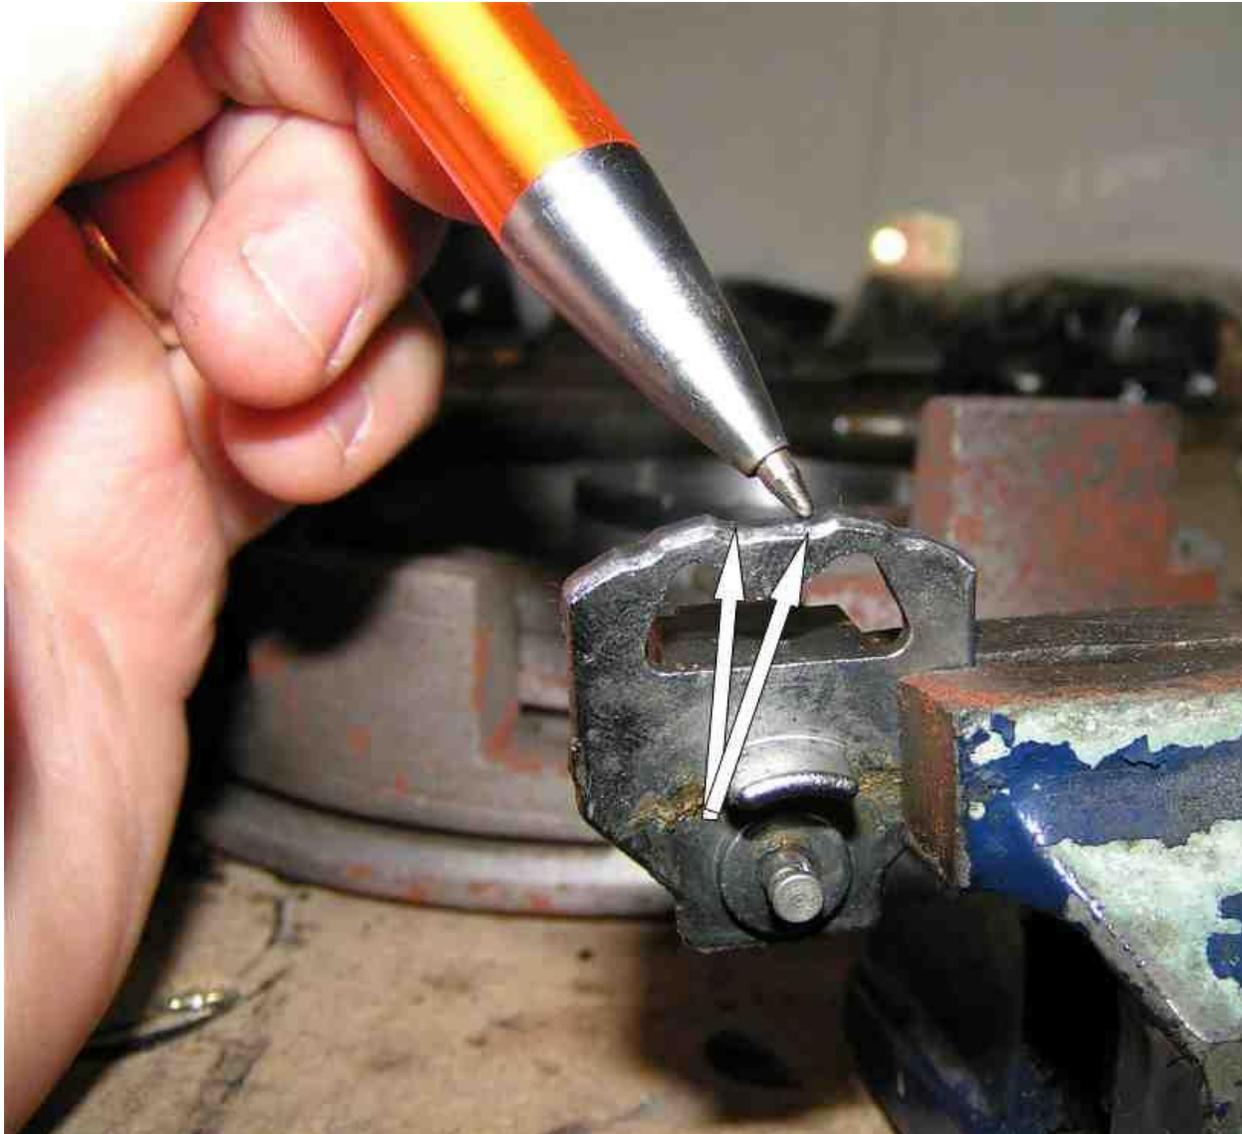
If the turn signal lever does not go to the normal position by itself after activating the turn signal or wiper, this may be due to a burr at this point (arrow). The ball is in the notch [hole] when the lever is in the middle [normal] position. Often there is a burr on the left and right of the notch. If this is too big, the ball will jam and not return to its original position. Just remove the burr with a file and it will work again.

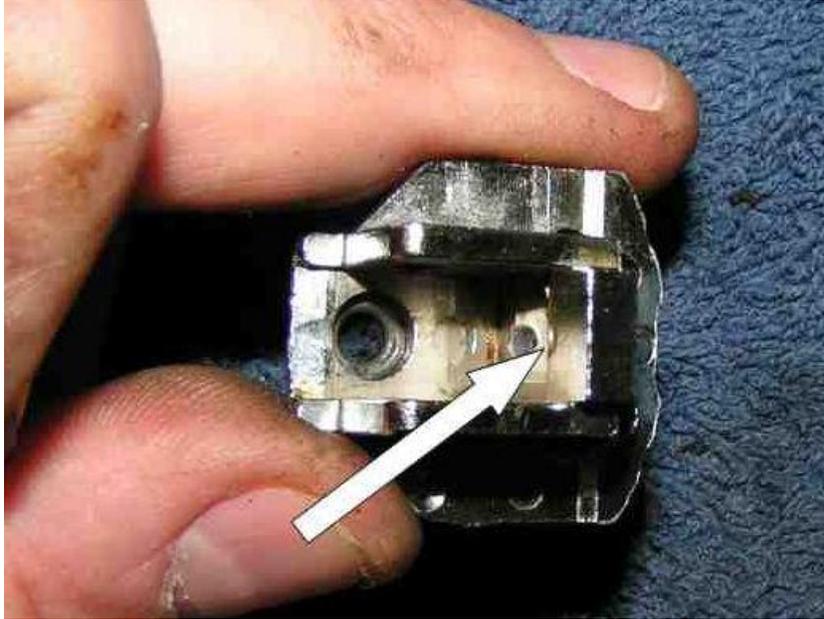
Before we assemble the switch, release this spring on one side. It pulls the two "levers" together with the rollers. If we release the spring, the levers can be moved to the left and right and we get better lever movement.

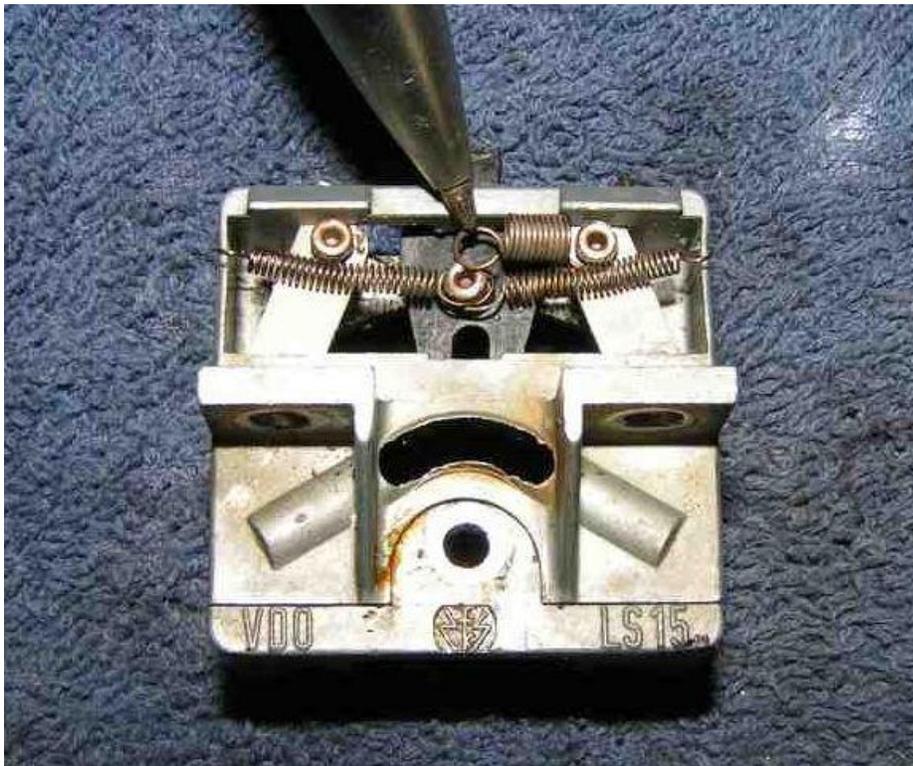
It makes sense to clean the contacts (also the opposing parts).

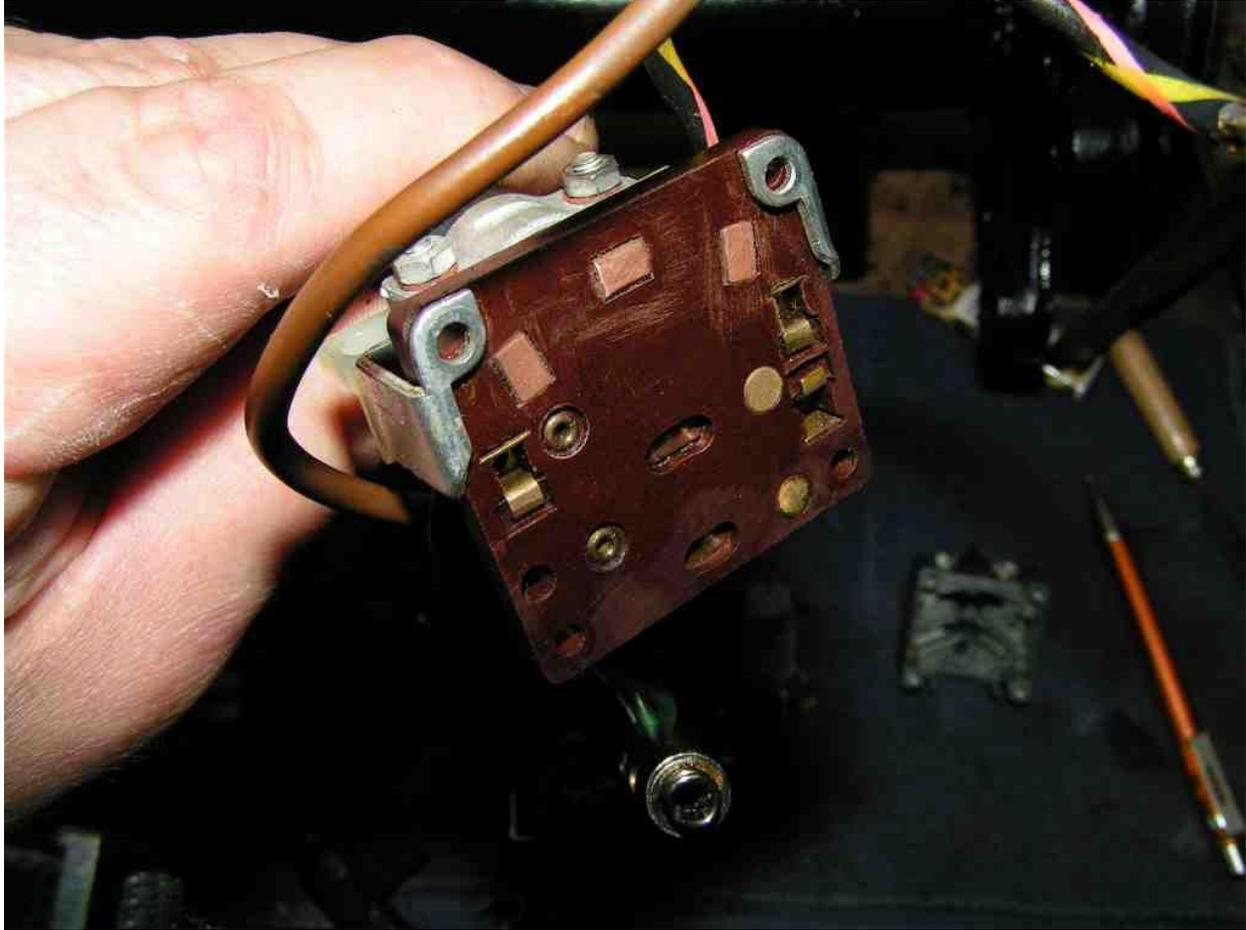
Now we take the housing, put the two levers to the side and push down the black part that releases the lever. It is somewhat difficult because the nose [tip] is reintroduced into the springs (which we had used before, of course).

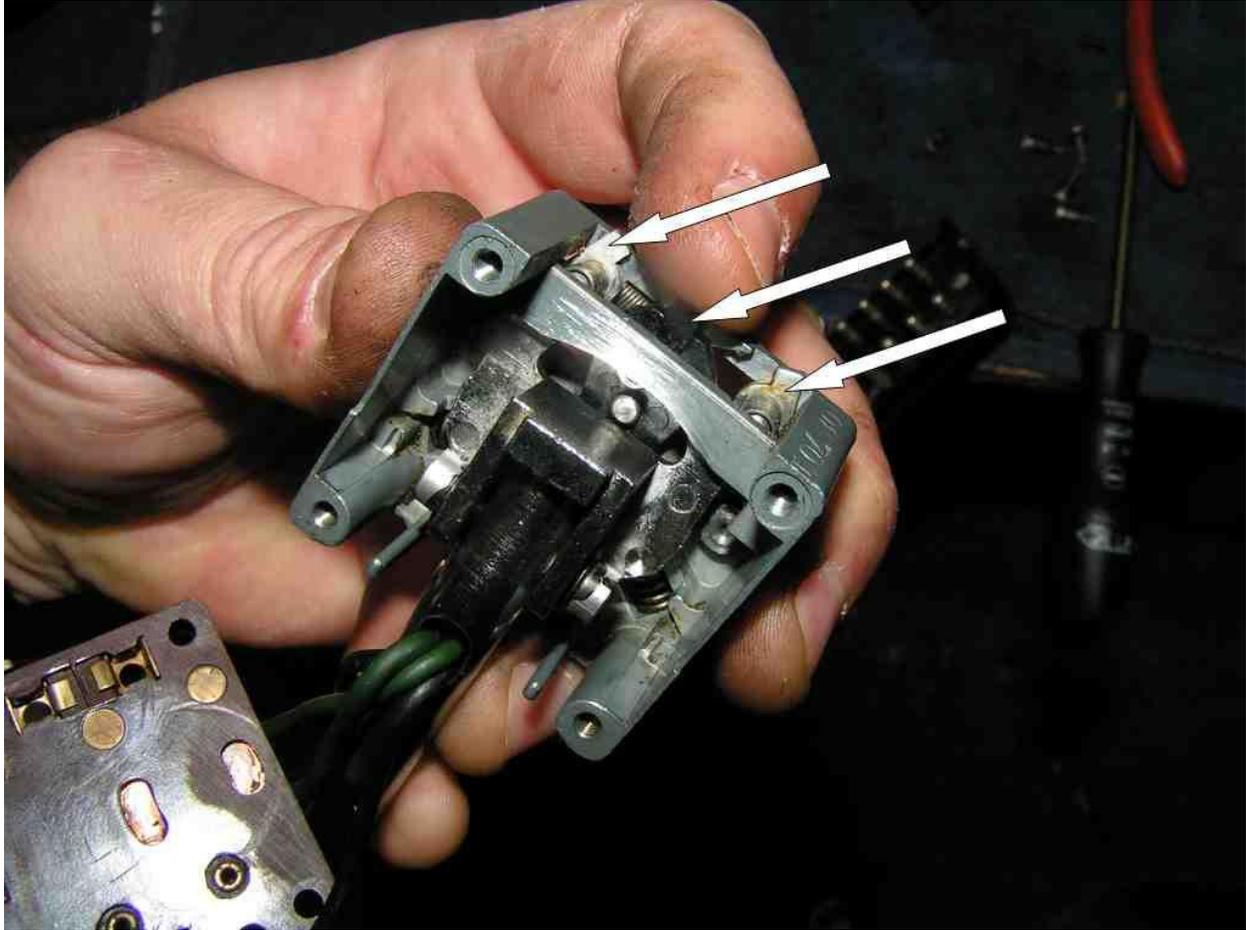
When this is done, use pliers to pull the pin out, onto the washer and snap ring. On my first attempt, I did not know this and was very frantic. The gouges in my kitchen table still bear witness ....

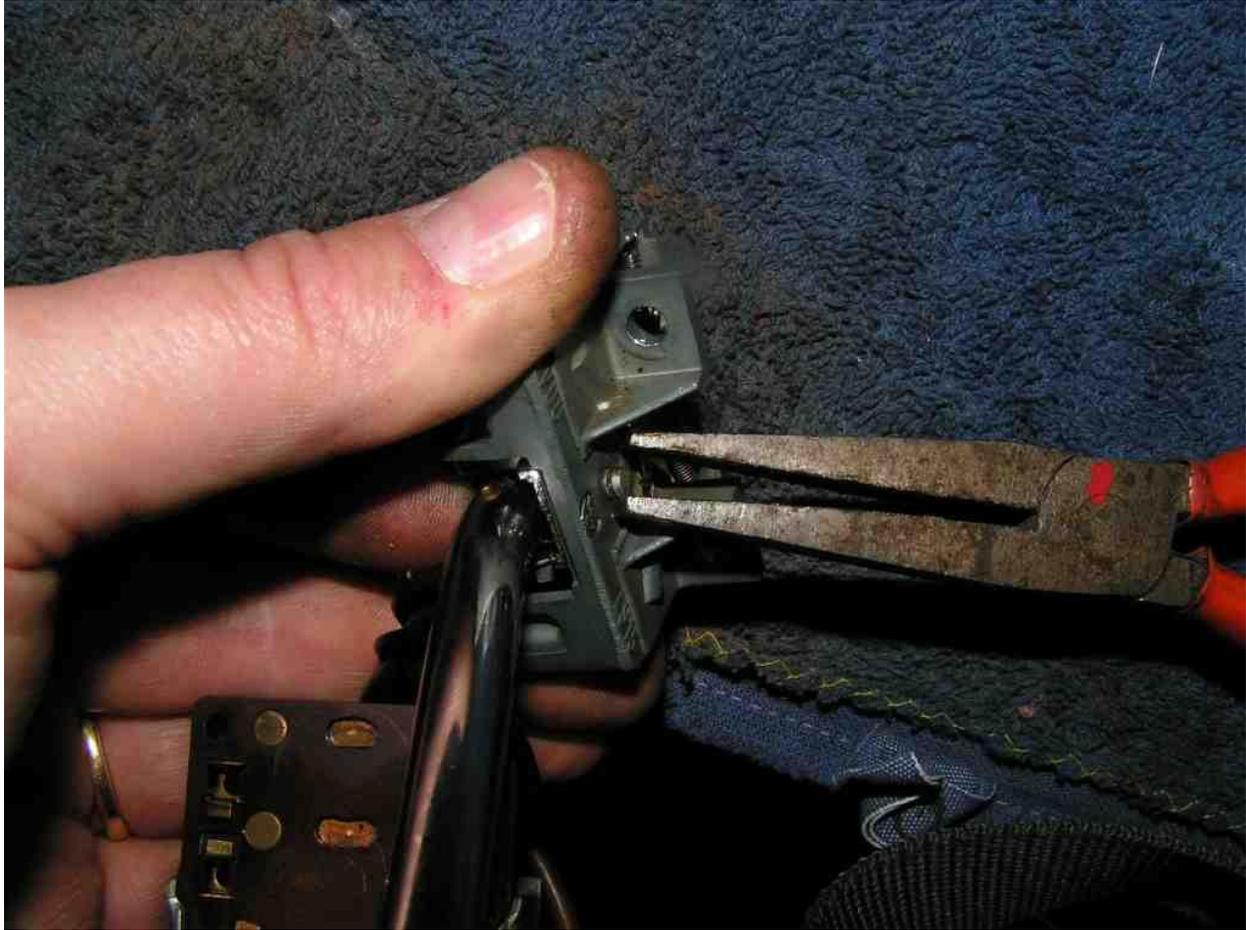
When done, reassemble the Bakelite part mentioned at the beginning with the "switches" and springs. Replace the contact plate for the turn signal function (flattening it upwards!) and insert into the groove. Now with your "3rd hand" put the Bakelite lid back on. Replace the 4 screws.
